Report No. UT-03.15

***SEISMIC REHABILITATION
OF CONCRETE BRIDGES:
VERIFICATION USING IN-
SITU TESTS AT SOUTH
TEMPLE BRIDGE ON
INTERSTATE 15***

Final Report

**Utah Department of Transportation
Research Division**

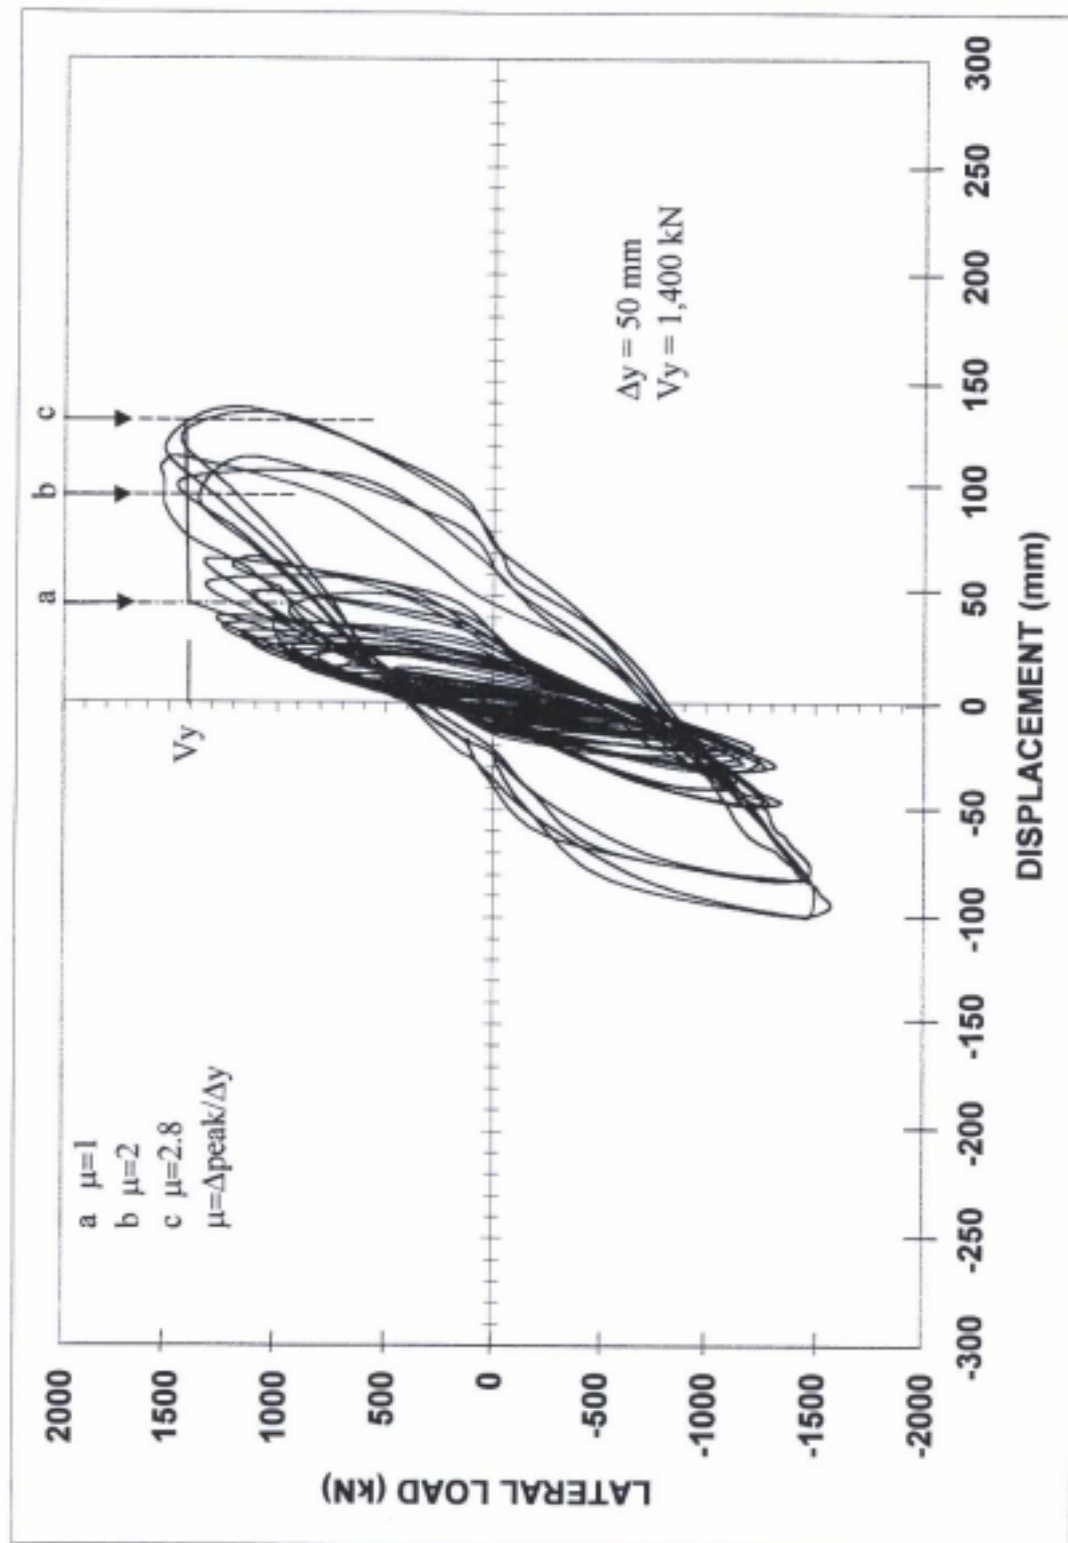
The load-displacement hysteresis curve for Bent #5 is given in Fig. 31. The first yielding occurred at the top of the middle column. The first yielding of the column occurred at a lateral displacement of 29 mm (1.14 in.), corresponding to a lateral load of 801 kN (180 kip). These values are within 4% and 9% of the values obtained from analysis, respectively. From a bilinear approximation of the load-displacement behavior, the displacement ductility of the bent at the end of the test was found to be equal to 2.8, as shown in Fig. 31. This is reasonable for bridges of this type built in the 1960's, which were not designed for earthquakes. However, the bridge was designed for lateral wind loads.

Figure 31. Hysteresis curves for Bent #5

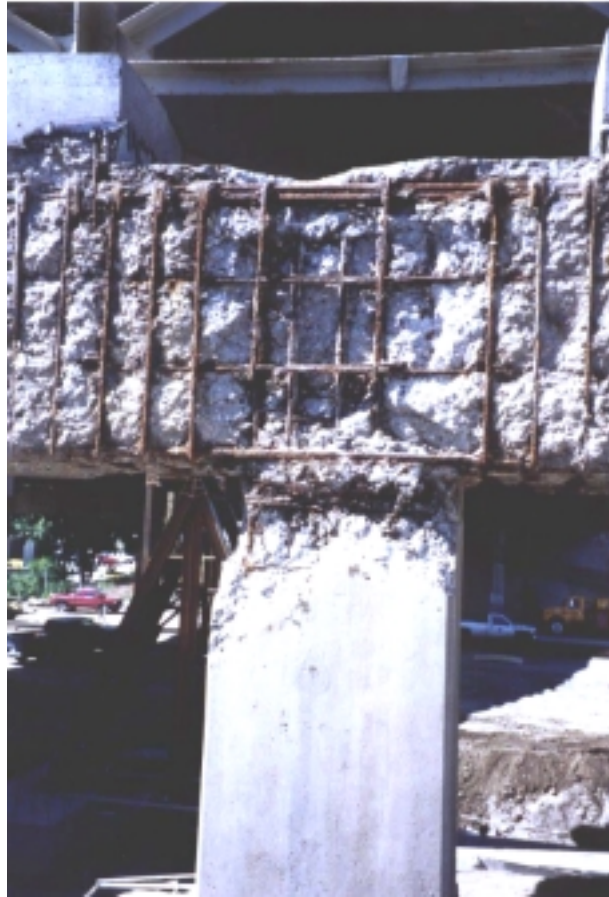
the south side, suggesting bar slippage and severe deterioration of reinforcement bond. This was observed after removal of the concrete for the joint of the interior column as shown in Fig. 36. In addition, at the substructure level, considerable concrete spalling at the top of the pile cap around the column perimeter was observed.

where v_j is the average of the horizontal and vertical joint shear. From equation (5.2), the principal tensile stress is obtained as $\sigma_t = 1.99 \text{ MPa}$, and the principal compressive stress as $\sigma_c = 2.53 \text{ MPa}$. Thus, the principal tensile stress is $0.44 (f'_c)^{0.5} \text{ MPa}$ or $5.26 (f'_c)^{0.5} \text{ psi}$, which indicates that the joint has developed full diagonal cracks and joint degradation is anticipated (Priestley et al. 1996). This is clearly shown in Fig. 36.

Figure 36. Bond deterioration and bar slippage at interior beam cap – column joint

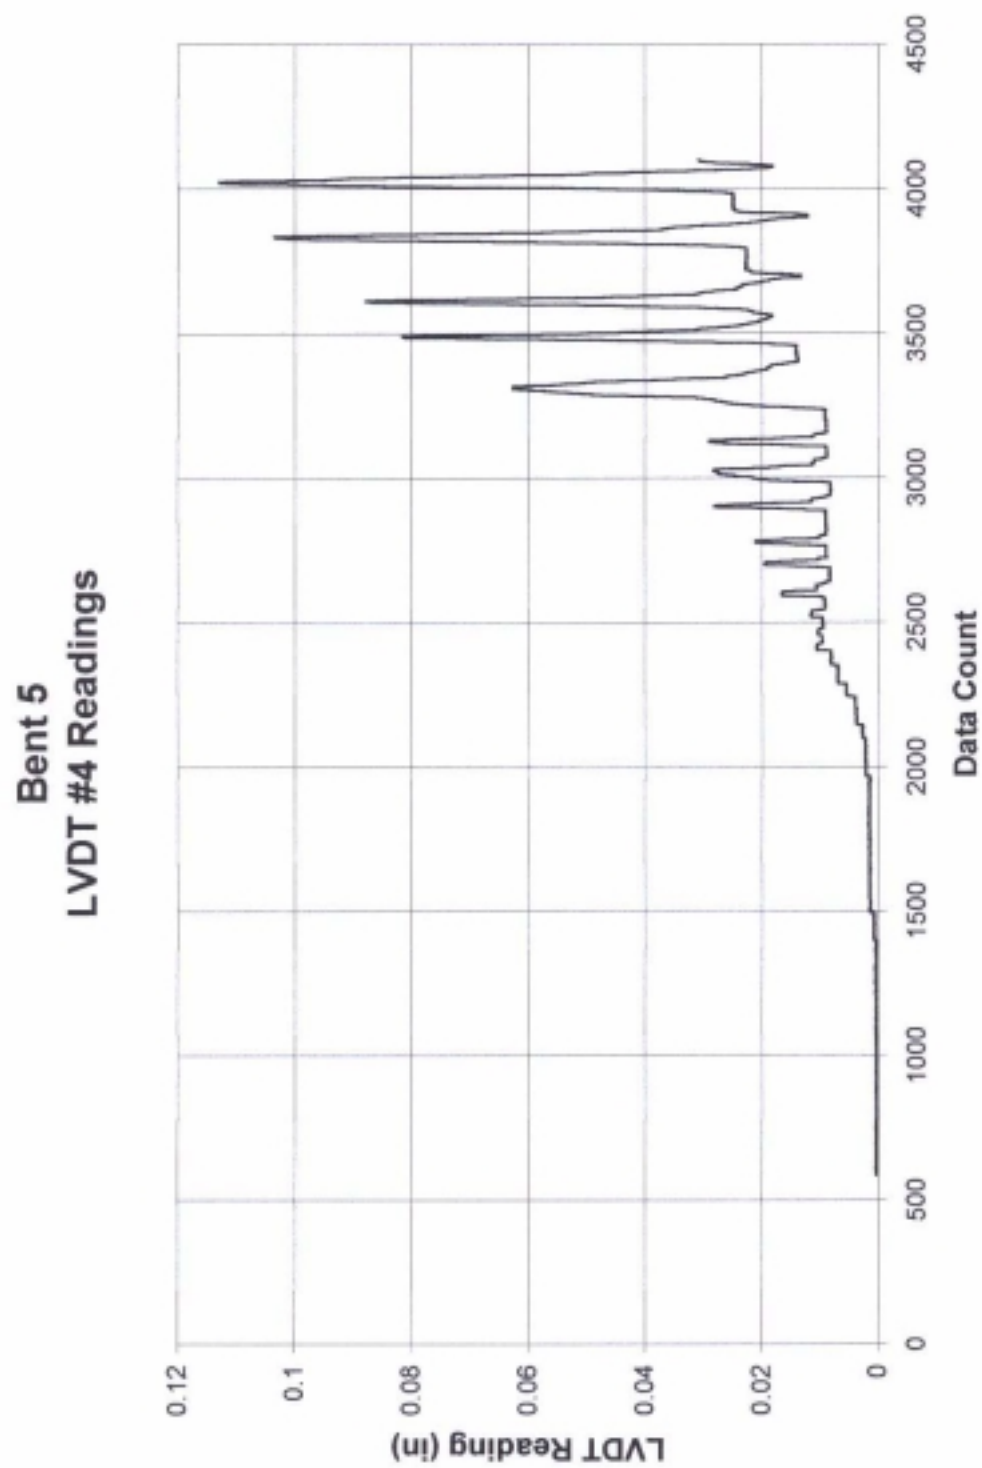
The actual distortion of the beam cap – column joints was determined from the LVDT measurements. Figure 37 shows the diagonal displacement of the beam cap to column joint nearest to the actuator. The maximum diagonal measurement was 3 mm (0.12 in). The shear strain in the same joint is shown in Fig. 38; the maximum strain is 0.003 in compression. The principal tensile stress in the interior beam cap – column joint was evaluated as shown in Fig. 39. The horizontal and vertical shear forces in the joint are: $V_{jh} = 1109 + 511 = 1620 \text{ kN}$; $V_{jv} = 3118 - 784 = 2334 \text{ kN}$. The corresponding horizontal and vertical joint shear stresses are:

Figure 37. Displacement of diagonal along exterior beam cap – column joint on Bent #5
(1 in. = 25.4 mm)

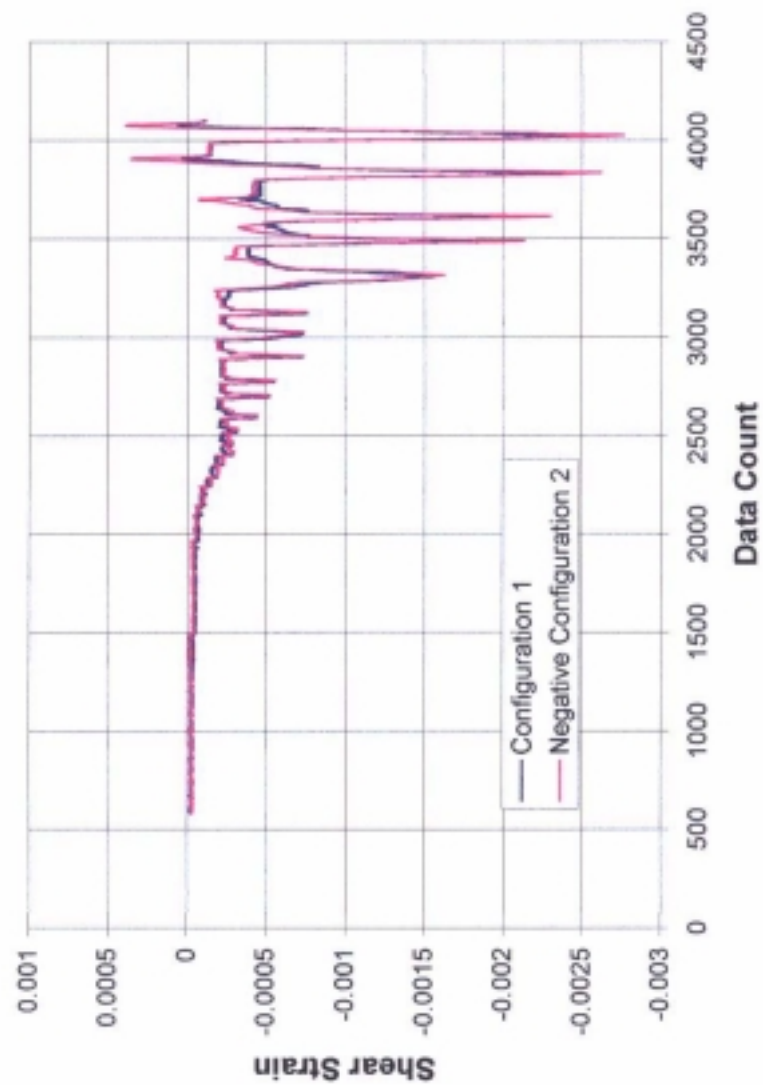
Figure 38. Shear strain at exterior beam cap –column joint of Bent #5

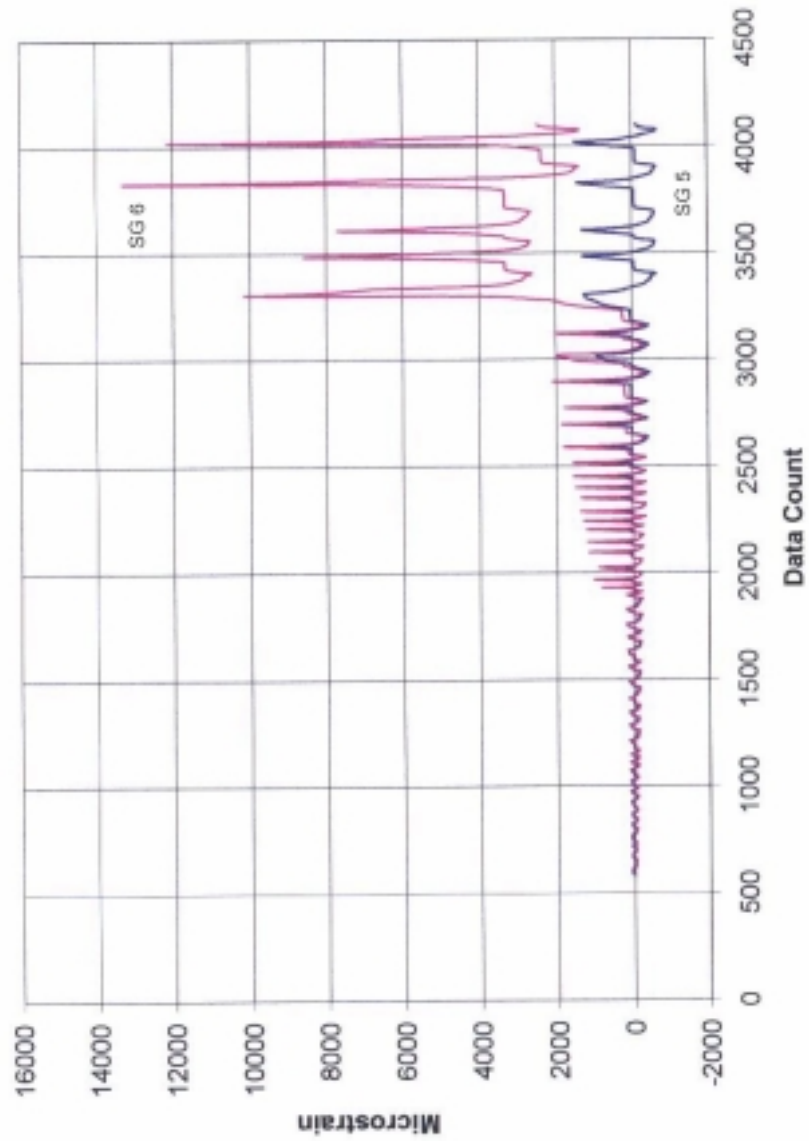
yield strain of 1380 microstrain. As illustrated in Fig. 41, strain gage 6 at the bottom of the exterior column closest to the actuator exceeded the yield strain early in the loading cycles. The strain at the end of the test reached 1.3% in./in. or approximately 10 times the yield strain. Figure 42 shows the strain in gage 24, at the top of the same column, and it exhibits similar behavior. Figures 43 and 44 show a force versus strain diagram for two of the columns of Bent #5. The diagrams show that the gage at the top of the column (gage 24) yields in the push direction whereas, strain gage 2 at the bottom of the column yields in the opposite direction. This suggests the development of an S-shape deformation pattern.

Figure 41. Strain gages 5 and 6 at the bottom of the exterior column on Bent #5

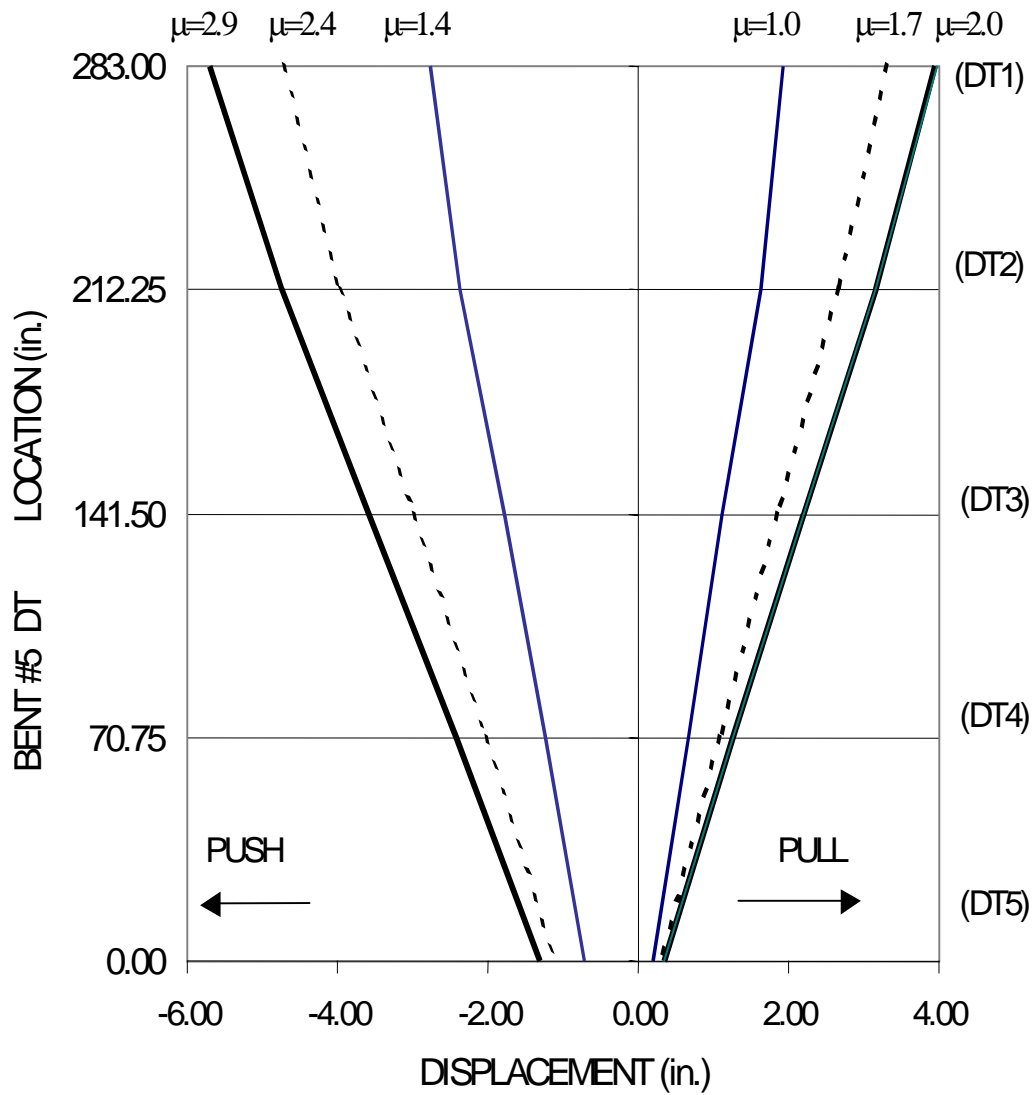
The displacements of the exterior column were recorded at 6 ft (1.829 m) intervals using displacement transducers 1 to 5, as shown in Fig. 28. The envelopes of the displaced shape at various drift levels both in the push and pull direction are shown in Fig. 45. The curve shows the displaced shape of an exterior column but it represents closely the overall transverse deformation of the bent. It can be seen that an S-shape has begun to form due to the yielding occurring at the top and bottom of the columns.

Figure 45. Displacement envelopes for exterior column of Bent #5 (1 in. = 25.4 mm)

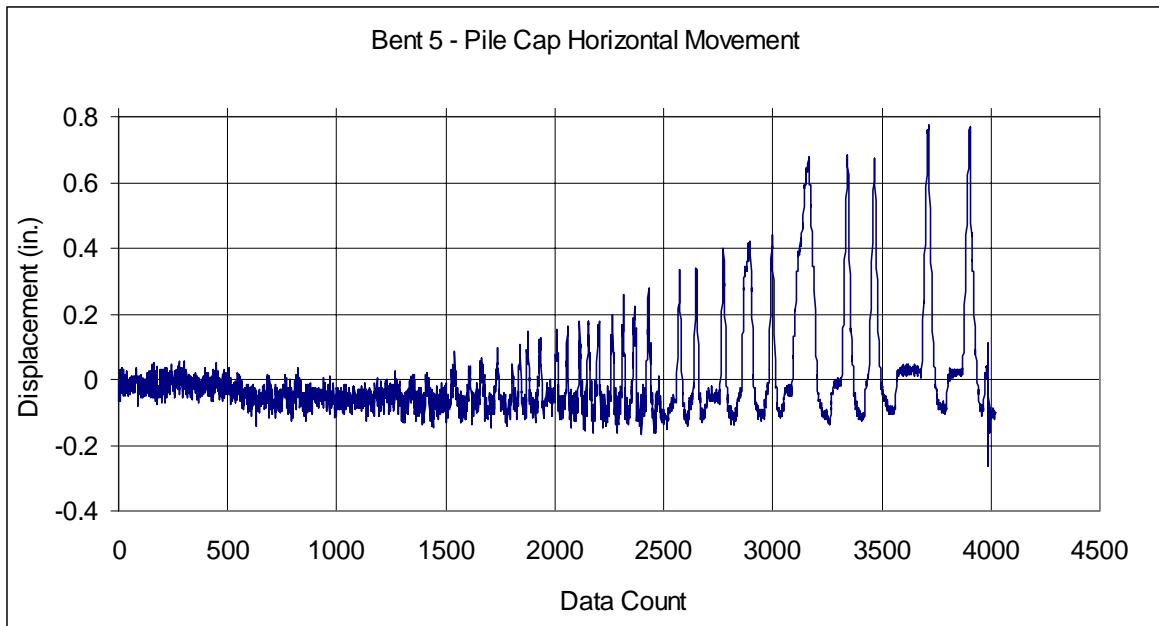
It must be noted that the data presented to this point do not include the effect of soil-pile-structure interaction, which as shown in Fig. 46 are significant. Figure 46 shows the displacement of the pile cap for Bent #5 which reveals that a maximum displacement of 0.8 in (20 mm) was reached. This is approximately 13 percent of the displacement reached at the beam cap of Bent #5. The topic of soil-pile-structure interaction is treated in detail in a companion report (Lawton et al. 2001).

Figure 46. Horizontal movement of pile cap of Bent #5 (1 in. = 25.4 mm)

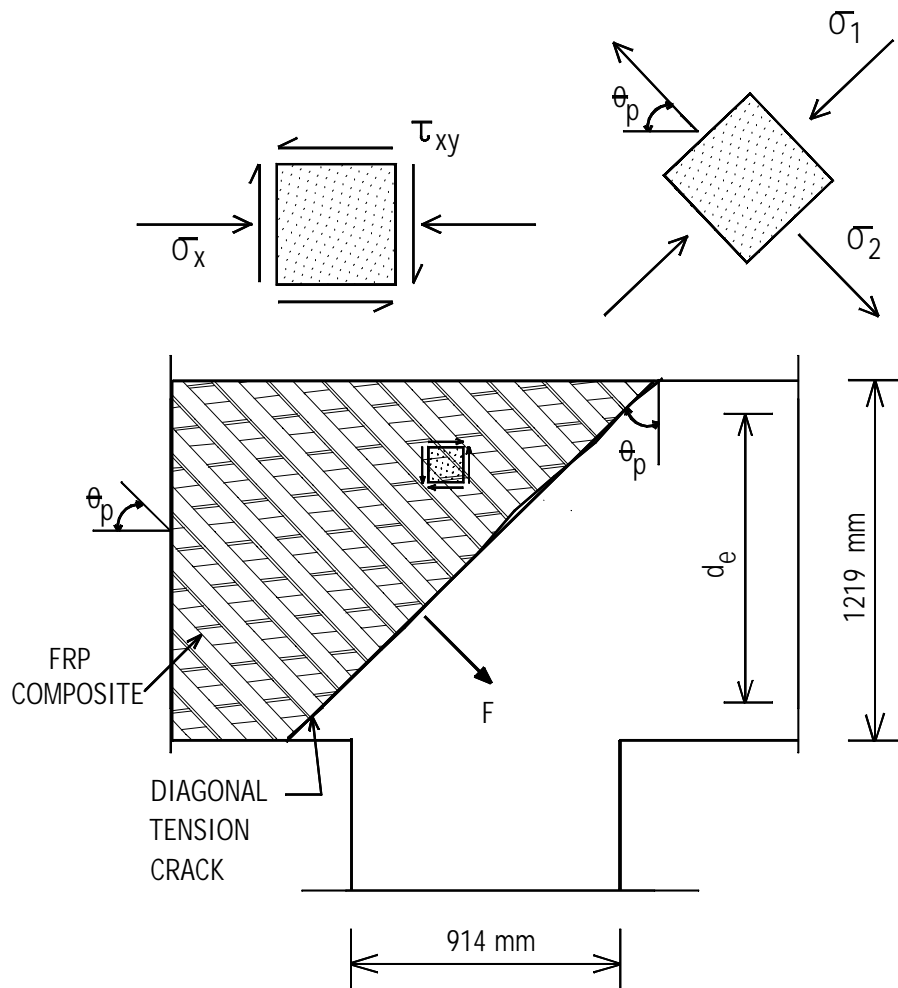
Figure 51. FRP composite rehabilitation design of beam cap-column joint

which yields 3.65 layers. In order to have a symmetric composite jacket around the joint, four layers of unidirectional fibers were applied. These layers were provided in both directions to take into account the cyclic nature of the applied test loads.

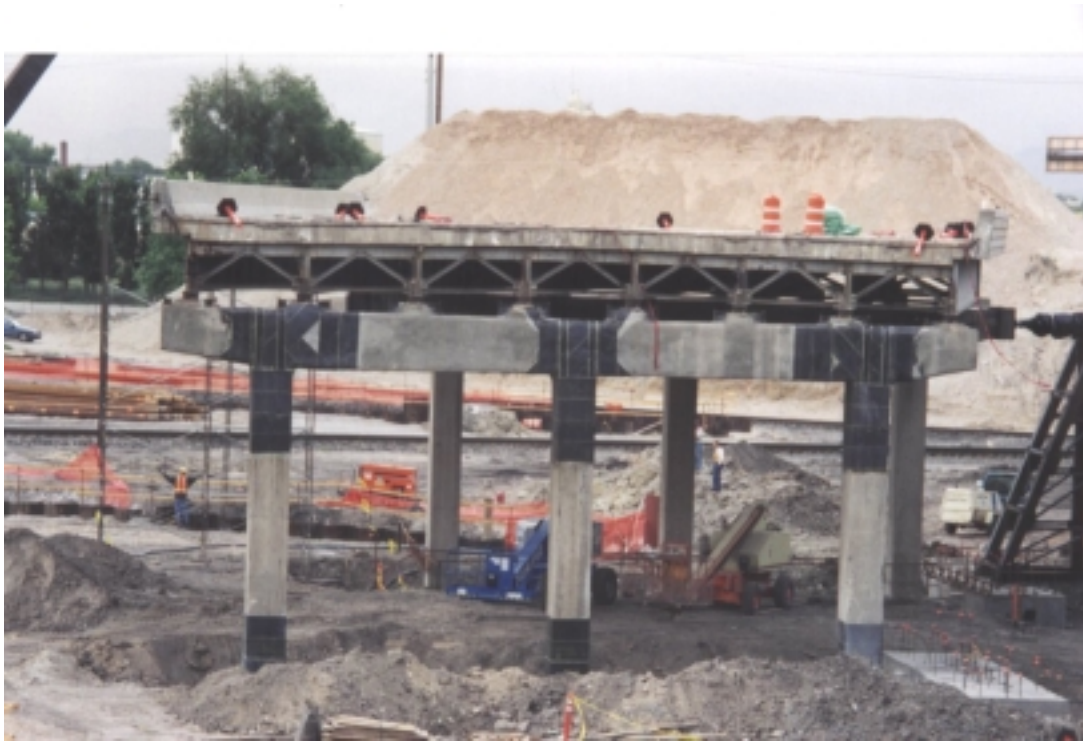
Figure 57. Overall rehabilitation of Bent #6 with FRP composites

The application of the composite included: (a) removal of loose concrete using jack hammers and surface preparation with high pressure water jet; this involved mainly the beam cap surface area and it was necessary to remove the cover outside the stirrups; this operation is extremely important in order to ensure a good bond to the existing concrete that is in good condition; (b) shotcreting of the surface of the beam cap to bring it to its original shape; a wire mesh was used at the bottom of the beam cap for the shotcrete to adhere; (c) application of a structural adhesive; and (d) application of the carbon FRP sheets using hand layup and a room temperature curing system. Good surface preparation and the use of a high strength adhesive prolong the onset of delamination of the composite from the concrete surface; this was the dominant mode of failure of the composite, which occurred at about only one fifth of the composite's tensile capacity. Strain gages measured the peak value of the strain in the composite at the joint which was found to be 0.22%. The ultimate value for tensile strain in the CFRP composite was determined experimentally as 1%. The low strain level observed in the FRP composite during the tests verifies the validity of the value used in the design of the

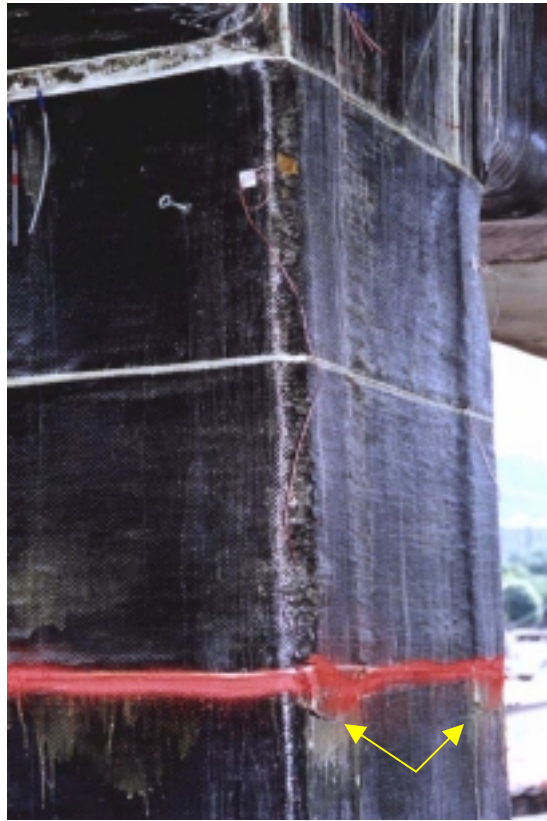
delaminated in the beam cap-column joint region, as shown in Fig. 67, and at the top and bottom of the columns as shown in Fig. 68. This occurred because of the low concrete strength in surface tension. The outside carbon fiber layers had visible flexural cracks along the fiber direction. Tensile failure of the 152 mm tensile composite tapes was observed as shown in Fig. 68 and Fig. 69. Strain gages measured the peak value of the strain in the composite at the beam cap-column joints, which was found as 0.22%, which was about a fifth of the ultimate strain value of 1%. This low strain level in the advanced composite verifies the value used to design the FRP composite design for shear strengthening of the beam cap-column joints.

Figure 69. Tensile failure of FRP composite in the U straps on the columns

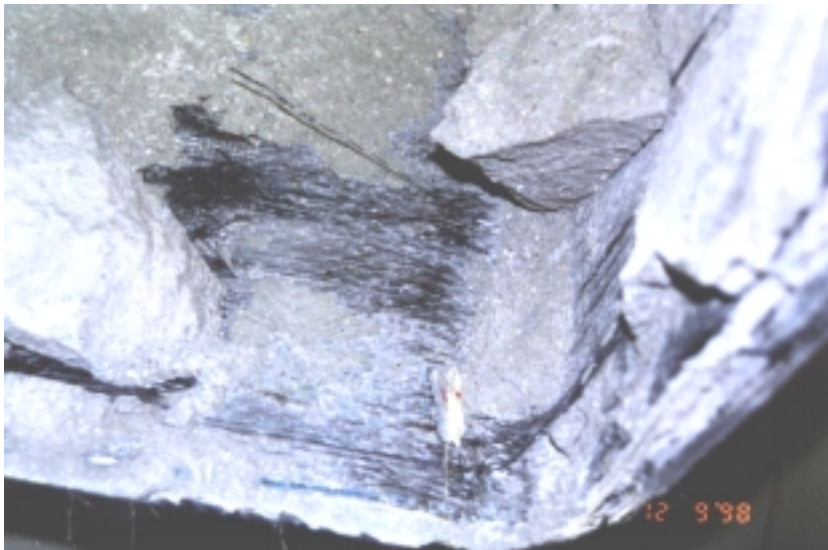
The quality of the FRP composite application and the FRP composite material itself was examined after the test on Bent #6 after demolition. For the most part the saturation of the fibers was good even though some dry fibers were occasionally found as shown in Fig. 72. The use of a saturator would alleviate this problem. The bonding of the FRP composite to the concrete substrate was varied. Even though the old concrete was removed and shotcrete was applied in the beam cap, there were still areas where the FRP composite delaminated with little resistance from the substrate concrete. However, in most areas a sufficiently good bond was observed as shown in Fig. 72. The water jet procedure is recommended after application of shotcrete for an even better bond. This is critical in areas such as the beam cap-column joint where the FRP composite contribution depends on the bond between concrete and FRP composite.

Figure 72. Condition of FRP composite and adhesion of FRP composite to the concrete

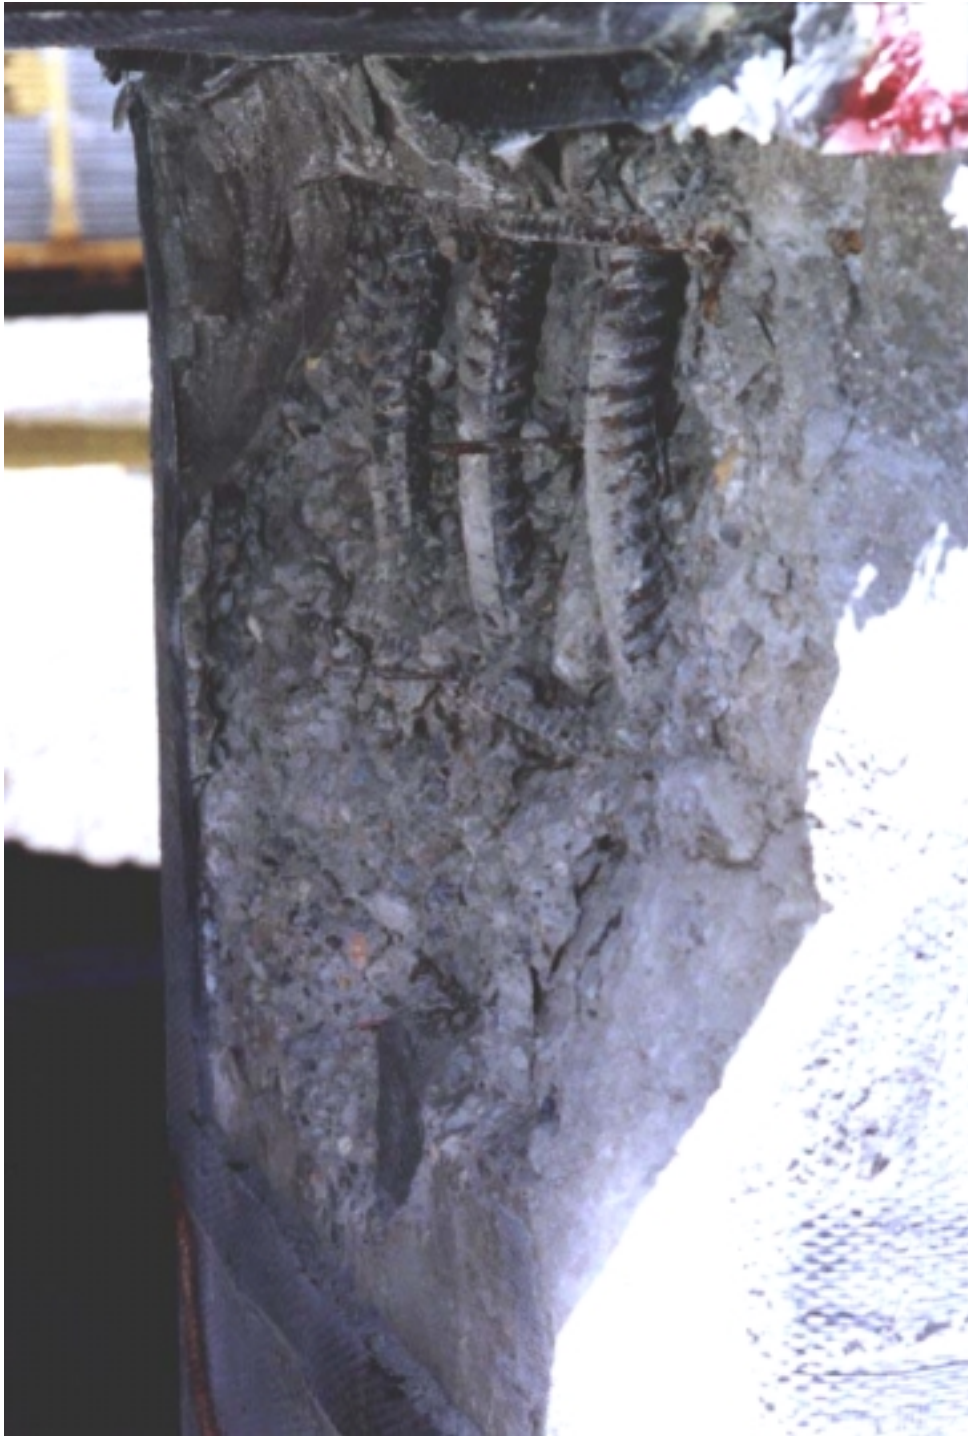
Upon removal of the FRP composite from the west-facing side at the top of the middle column, it was found that the longitudinal column bars had buckled as shown in Fig. 100 and 101. Since the applied load at the beam cap was in the push direction and the bars buckled in

that direction, and since the load was in the pull direction when it was working against the buckling, this explains the difference in stiffness identified in Fig. 96. Figure 102 shows that not only did the bars buckle between the column ties, but in addition the concrete between the ties was pulverized and had fallen out; this was determined after the FRP composite sheet was removed. This is in contrast to the situation observed during testing of Bent #6 as was shown in Fig. 71. The difference is the fact that Bent #5R had already been damaged in the first test of Bent #5; however effective the epoxy grout injection and shotcrete were they could not replace the integrity of the as-built concrete of Bent #6.

Figure 101. Buckling of longitudinal column bars on top of middle column

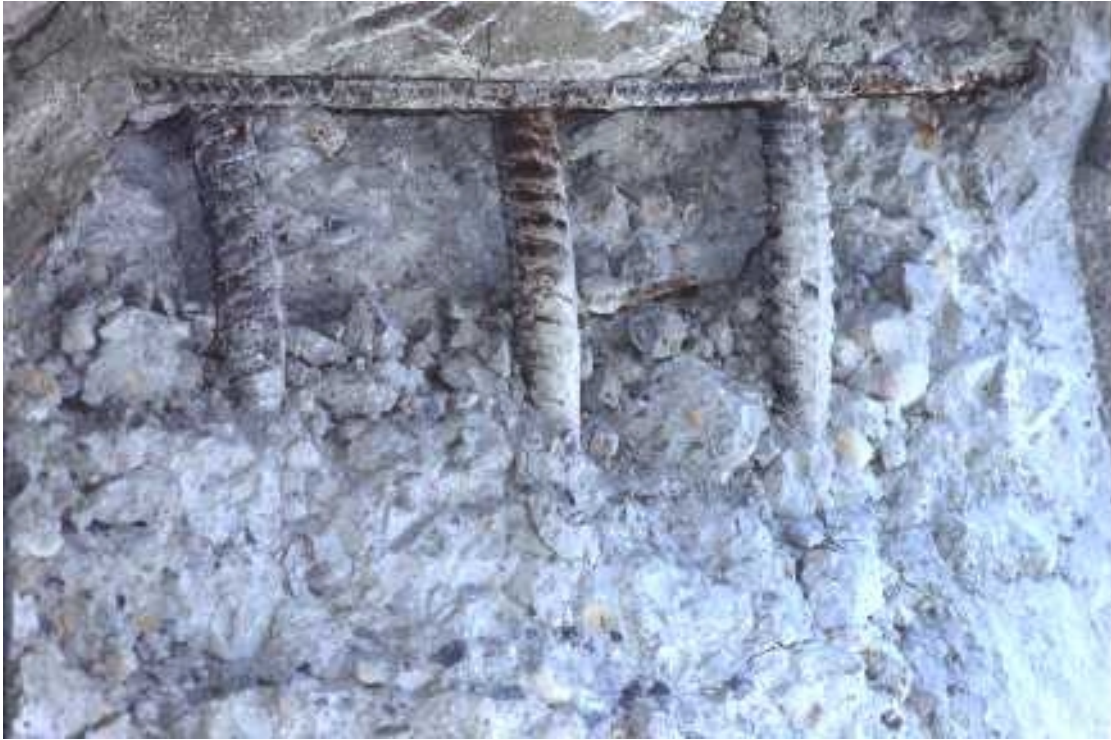
Figure 102. Pulverized concrete between ties of column of Bent #5R
